NL INDUSTRIES/TARACORP SUPERFUND SITE GROUP
2209 Quarry Drive, Suite C-35
Reading, PA 19609
Telephone: (610) 670-7310
Facsimile: (610) 670-7311

Re: NL Industries/Taracorp Superfund Site; Granite City, Illinois
First 2022 Semi-Annual Operation and Maintenance Inspection (June 28-29, 2022)

**NL Industries/Taracorp Superfund Site
Inspection Log - Operation and Maintenance**

Inspection Date: June 28, 2022

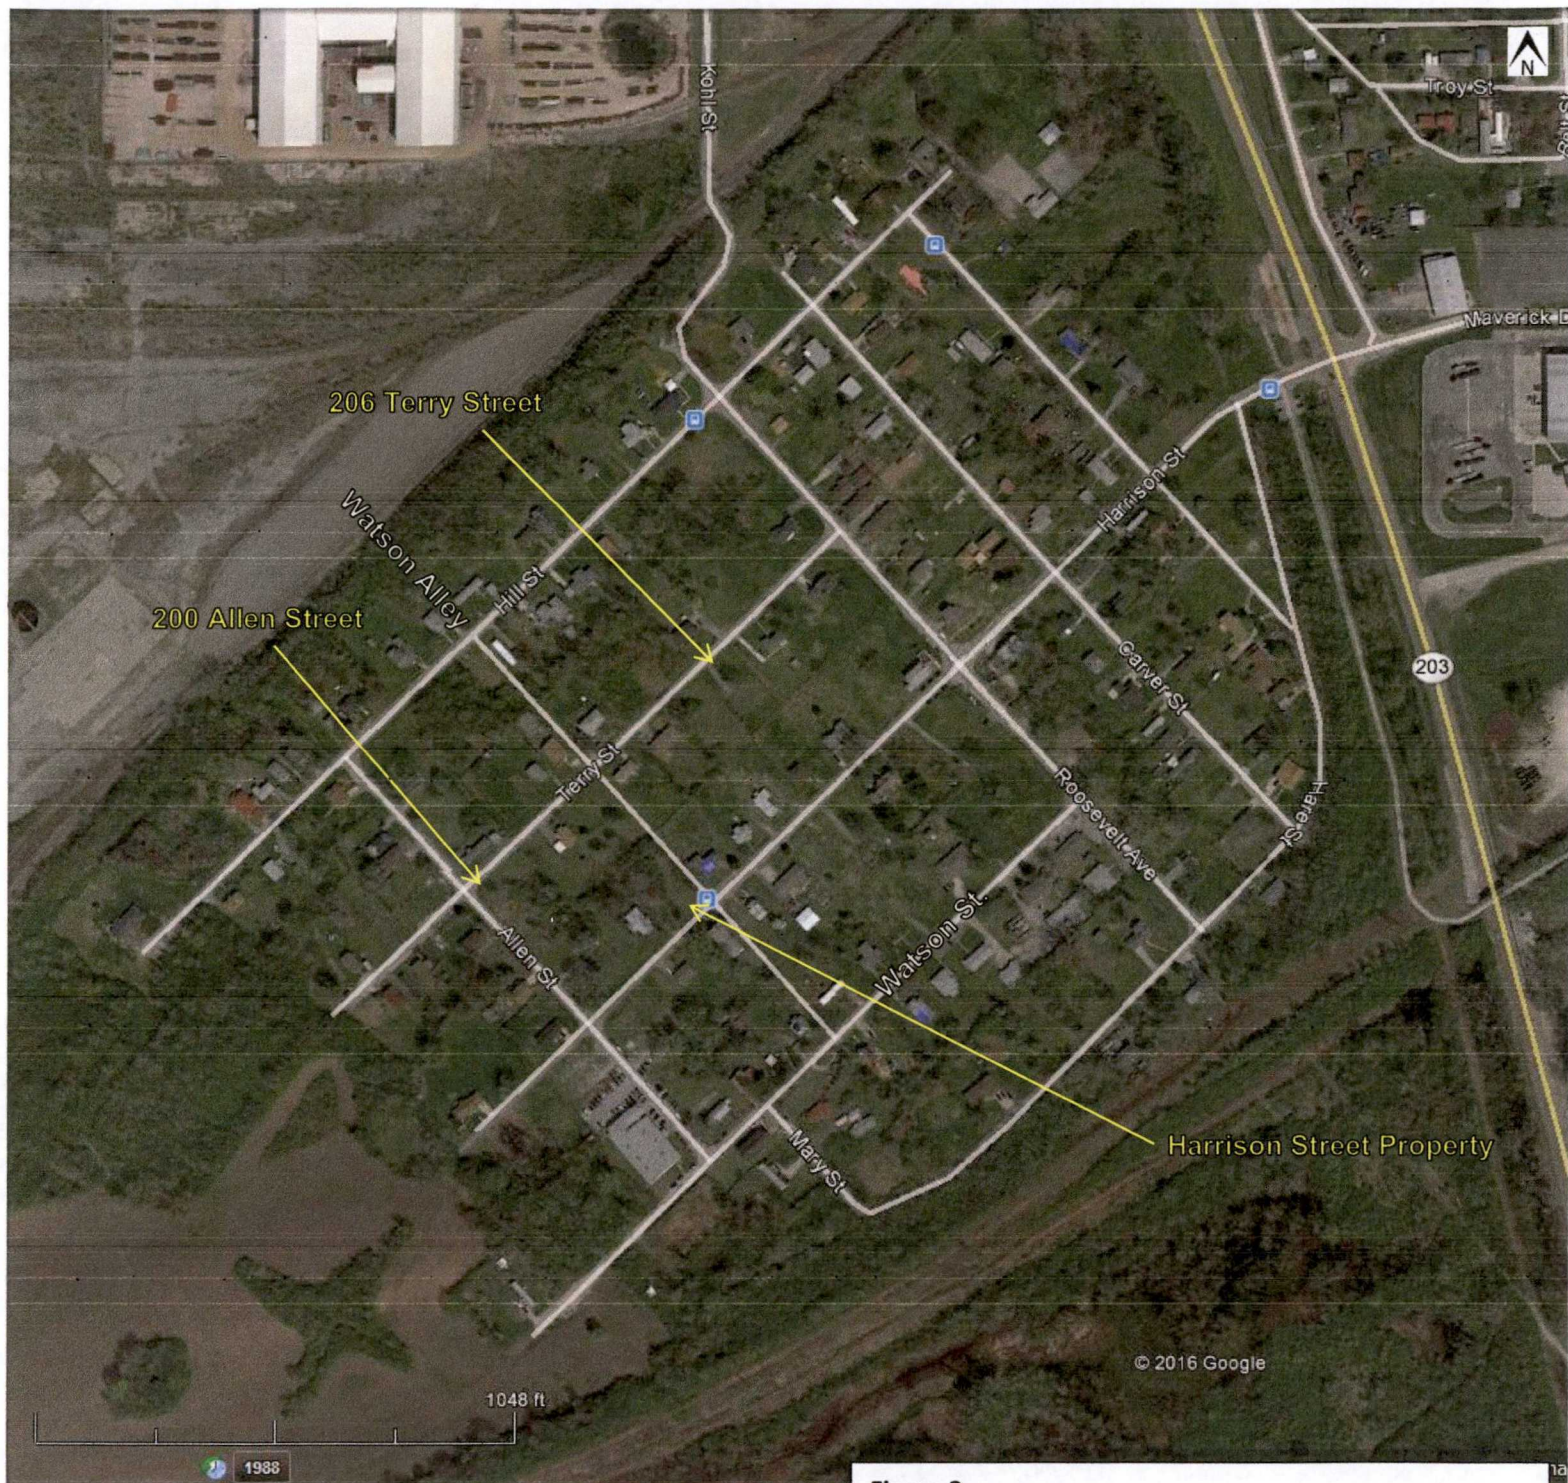
Figure 3
Eagle Park Acres - Remote Fill Properties (200 Allen Street, 206 Terry Street, and Harrison Street Properties)

- Two remote fill properties (200 Allen Street and 206 Terry Street) in Eagle Park Acres (Figure 3, Attachment 3) that were previously remediated by EPA (and where lead-impacted

- Two remote fill properties (200 Allen Street and 206 Terry Street) in Eagle Park Acres (Figure 3) that were previously remediated by EPA (and where lead-impacted soil and/or battery case chips may remain in place at depths of 2 feet and 3 feet below the ground surface, respectively) were observed during the inspection. As shown on the photographs in Attachment 3, the properties are vacant, vegetated, and no evidence of subsurface soil disturbance was observed.
- The Harrison Street property (Figure 3) where some scattered battery case chips were first observed in May 2019 was checked during the inspection. As shown on the photographs in Attachment 3, the property is vacant, vegetated (and recently mowed), and no evidence of subsurface soil disturbance was observed.

Photographs of remote fill properties provided in Attachment 3.

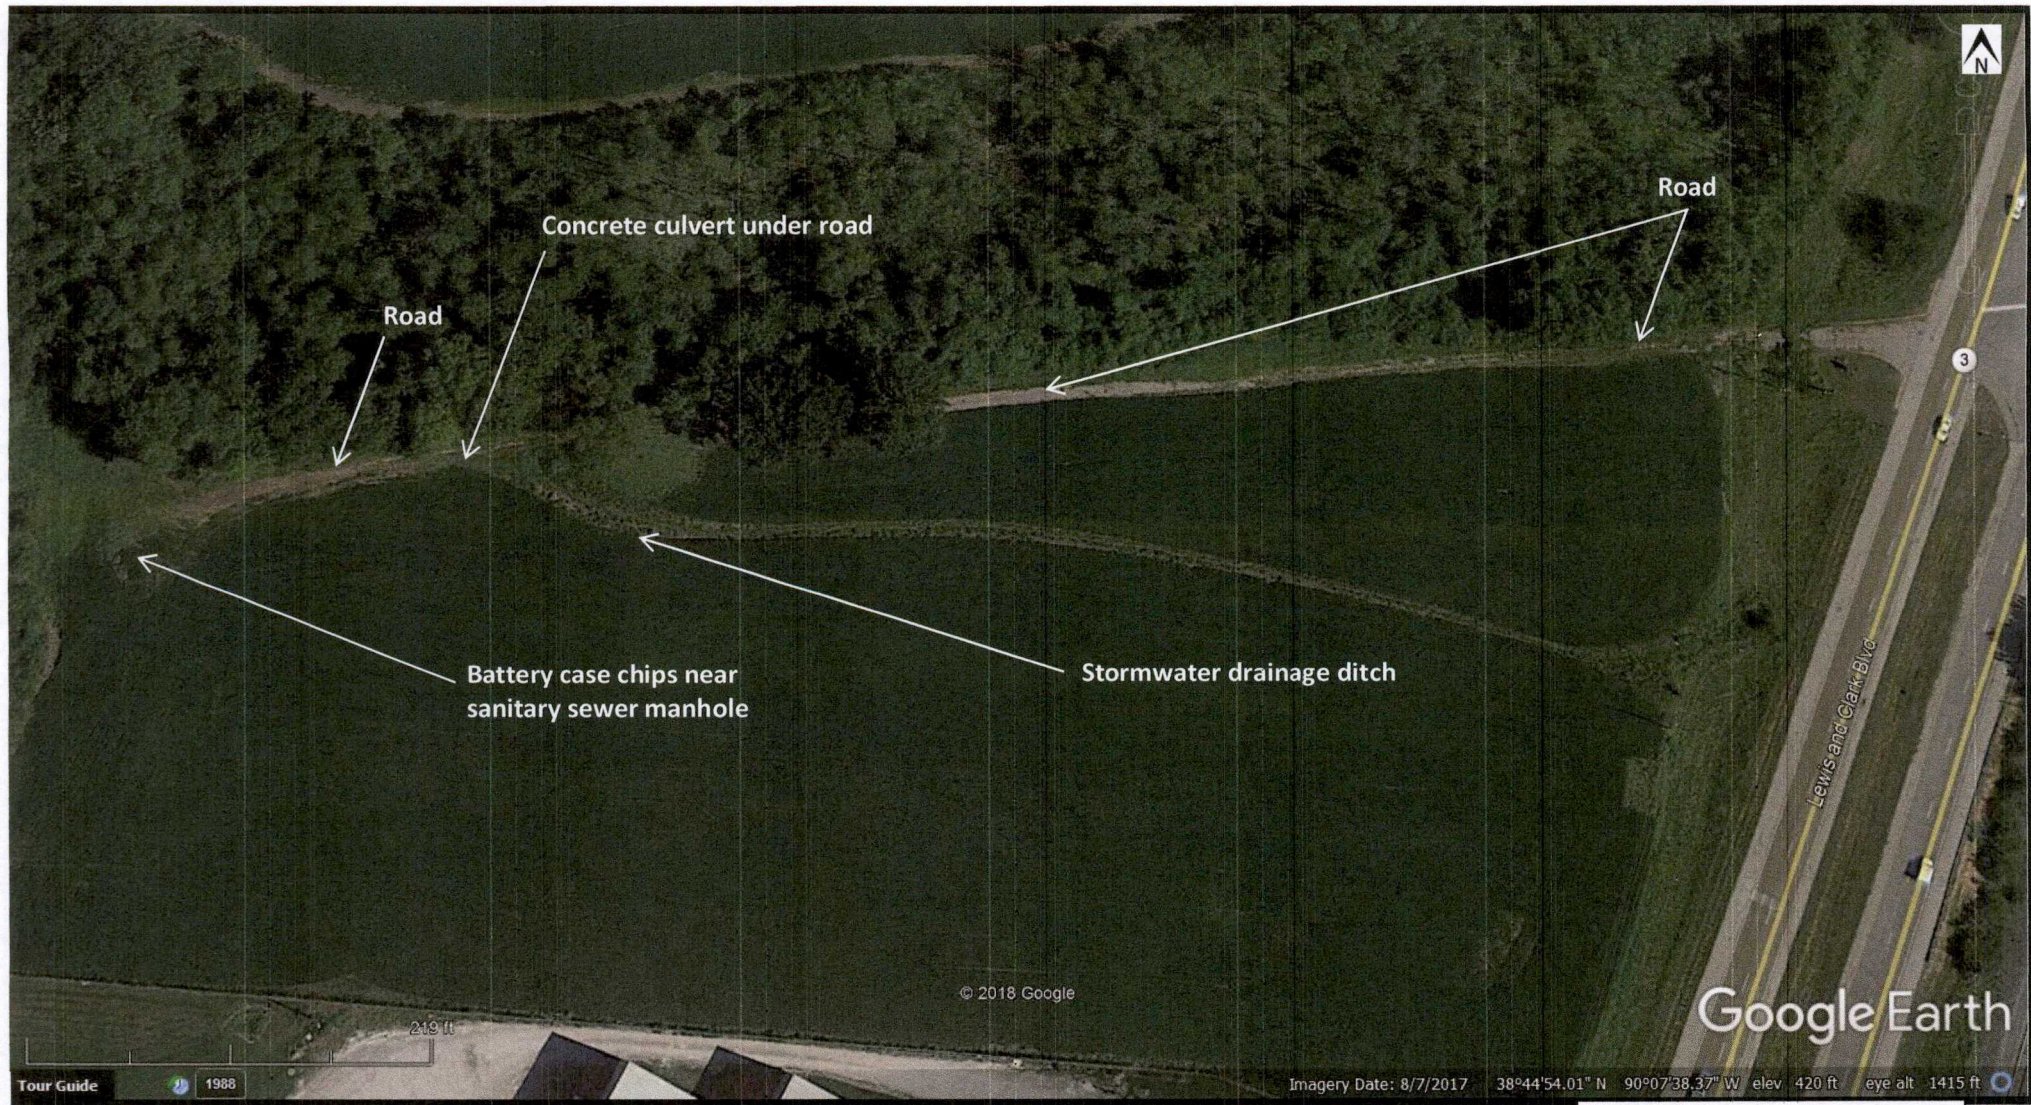
Figure 5
Schaeffer Road

- The warning signs around the Taracorp pile were securely affixed to the fences.
- As shown on the photographs in Attachment 6, no evidence of disturbance of the soil cover or asphalt roadway was observed at Schaeffer Road (a remote fill property remediated by EPA). Some scattered battery case chips were observed on the ground surface near the sanitary sewer manhole located near the western end of Schaeffer Road at the approximate location on Figure 5 and in a few small areas along Schaeffer Road.

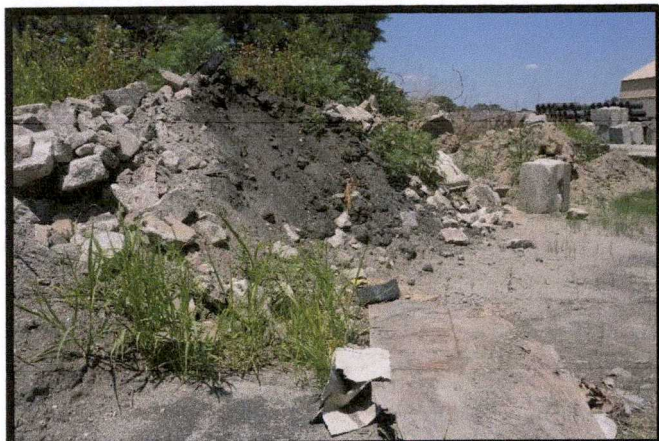
Photograph 7: Slough Road, concrete debris and soil piles.

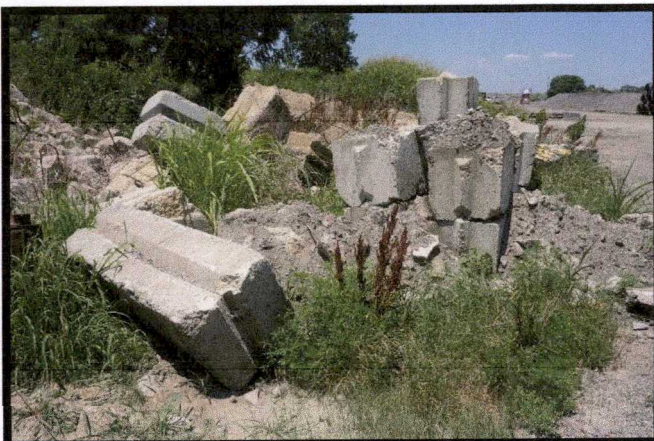
Photograph 8: Slough Road, concrete debris.

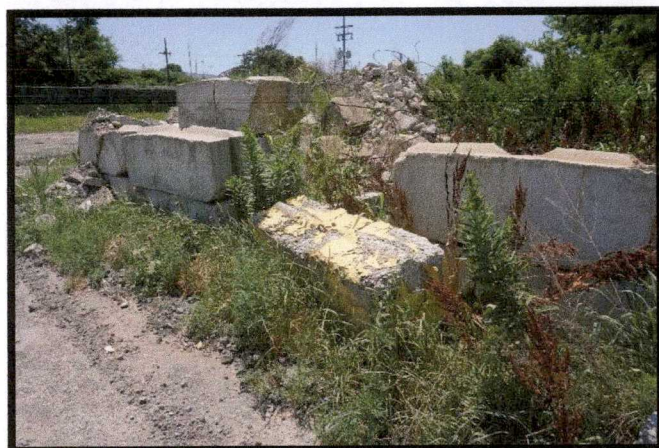
Photograph 9: Slough Road, concrete debris.

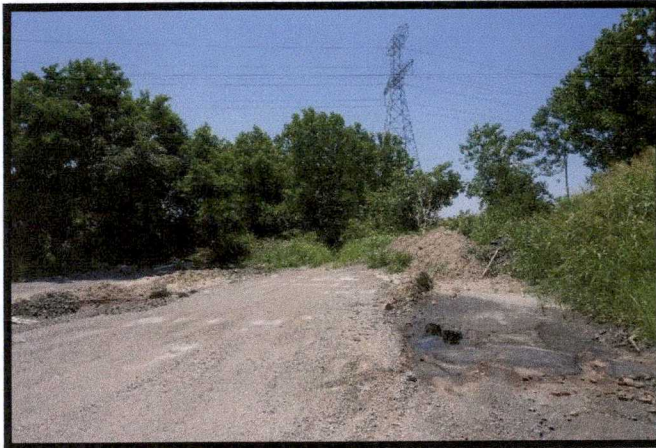
Photograph 21: Slough Road, former area of concrete foundation of former Robin's Nest lounge (new overhead electrical line in background).

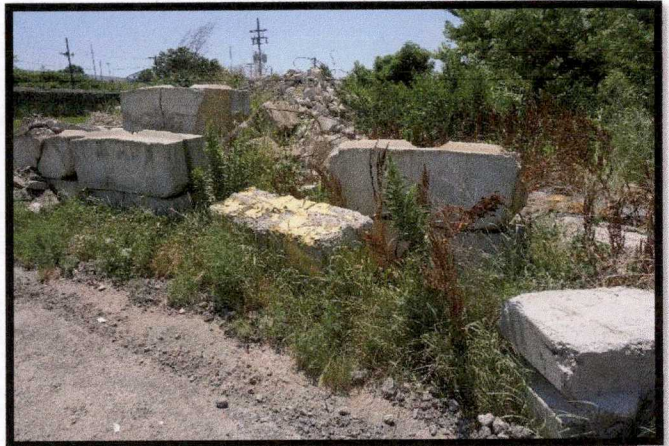
Photograph 22: Slough Road, concrete debris.

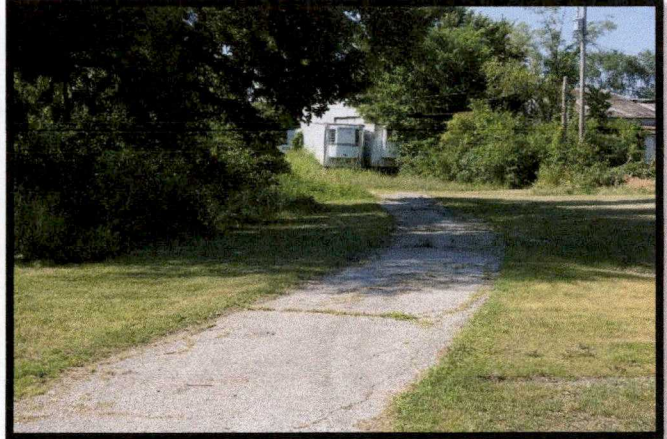
Photograph 2: EPA Alleys 34, 36, and 40 (view north from Brown).

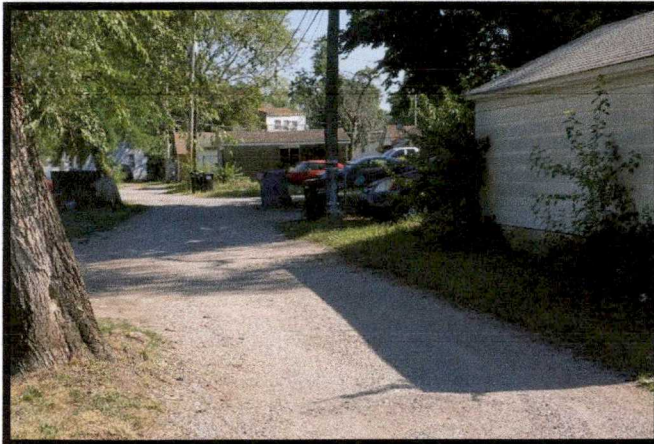
Photograph 3: EPA Alley 35, remediated by EPA (view south from Brown).

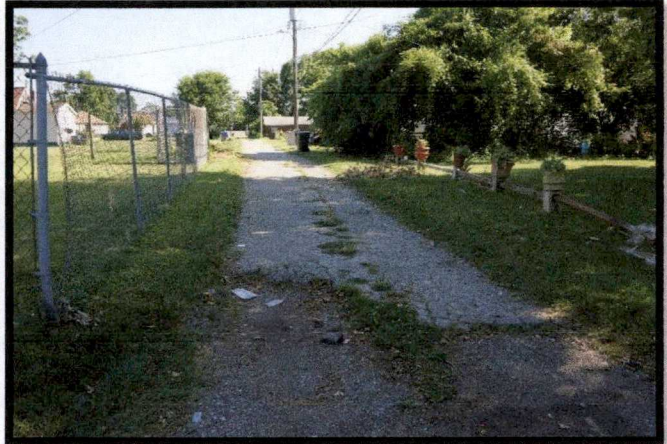
Photograph 4: EPA Alley 37 (view south from Brown).

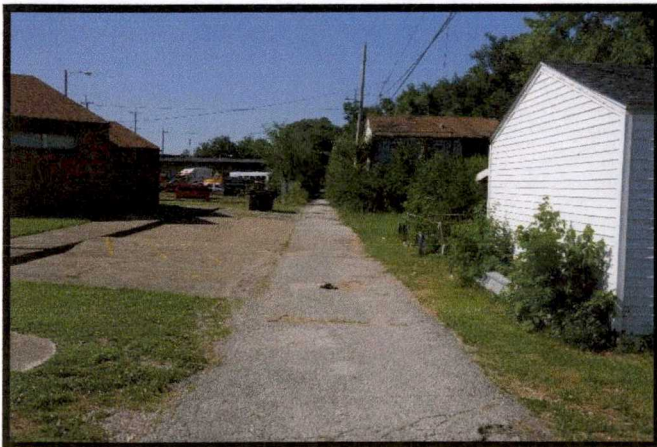
Photograph 5: EPA Alley 1 (view north from Brown).

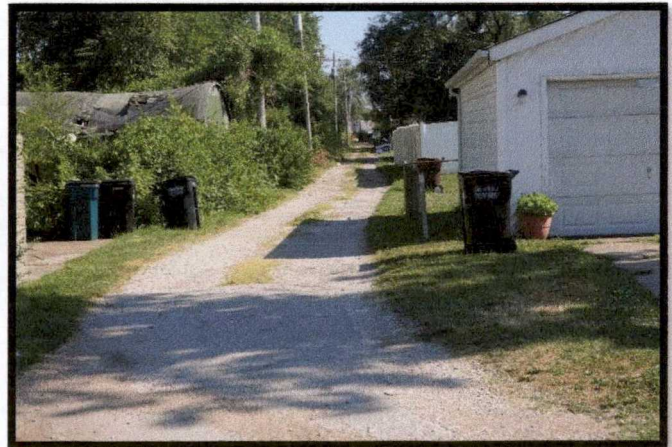
Photograph 6: EPA Alley 2 (view south from Brown).

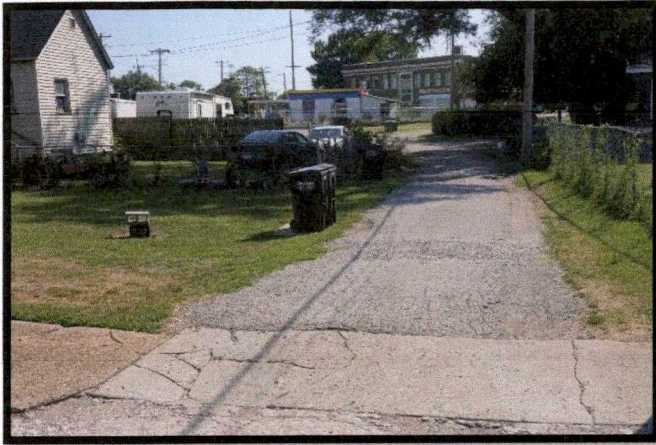
Photograph 7: EPA Alley 3 (view southwest from Oriole).

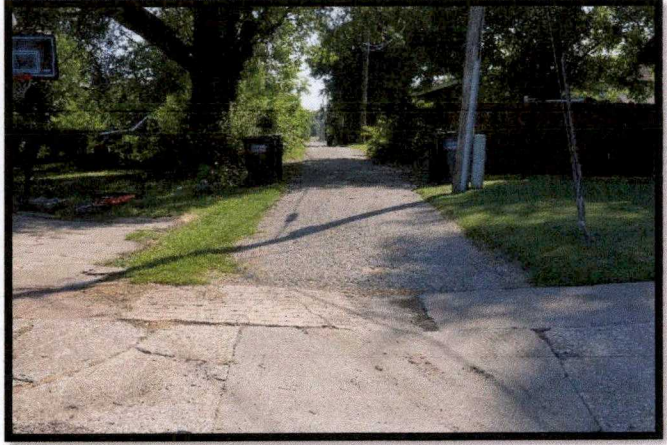
Photograph 8: EPA Alley 42, remediated by EPA (view southwest from 7th Street).

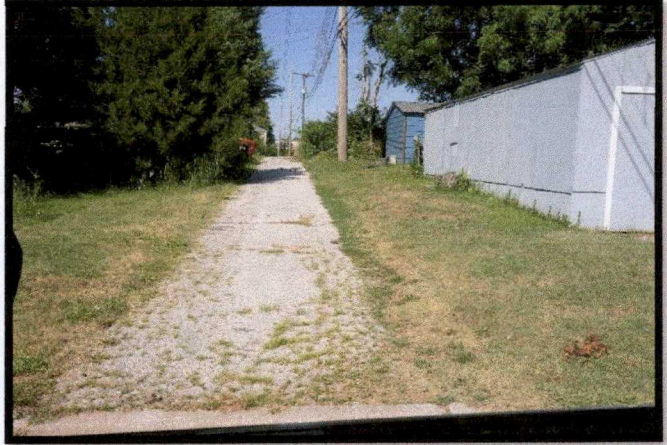
Photograph 10: EPA Alley 50 (view northeast from 6th Street).

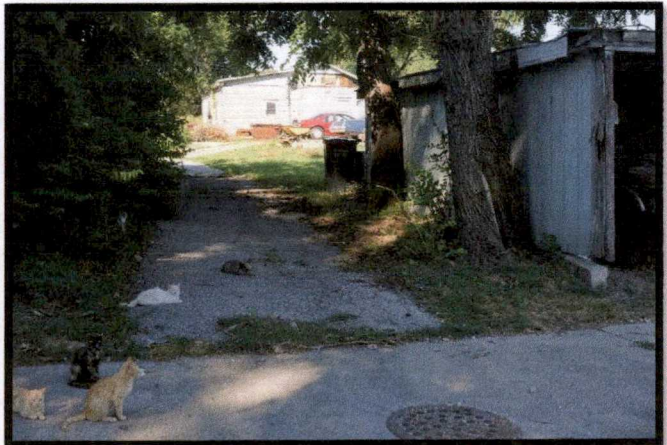
Photograph 12: EPA Alley 46 (view northeast from Klein Street).

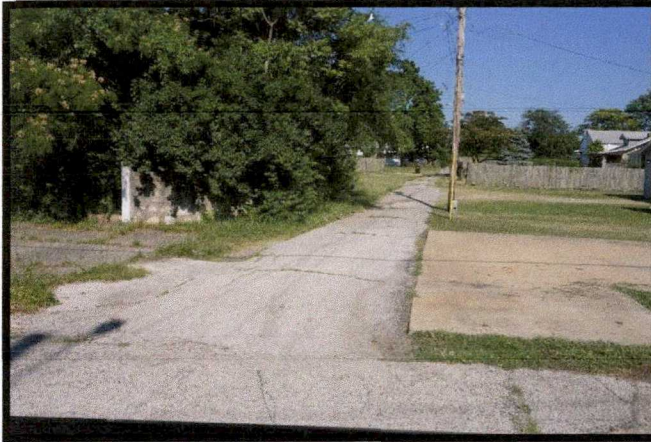
Photograph 13: EPA Alley 5 (view east from Baucum Street).

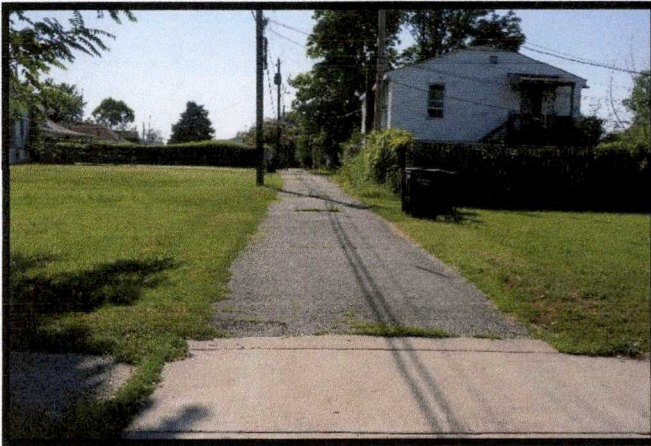
Photograph 15: EPA Alley 5 (view west from Meredocia Street).

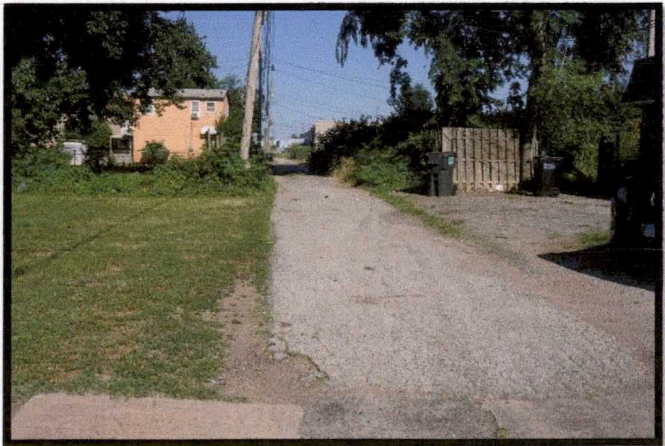
Photograph 18: EPA Alley 9 (view east from Selb Street).

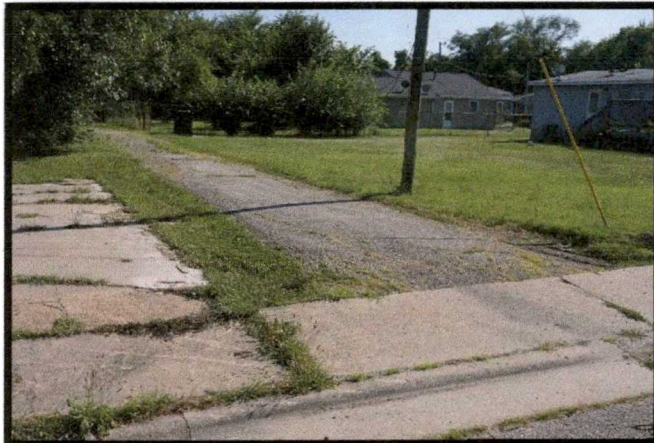
Photograph 21: EPA Alley 26 (view south from Rogan Street).

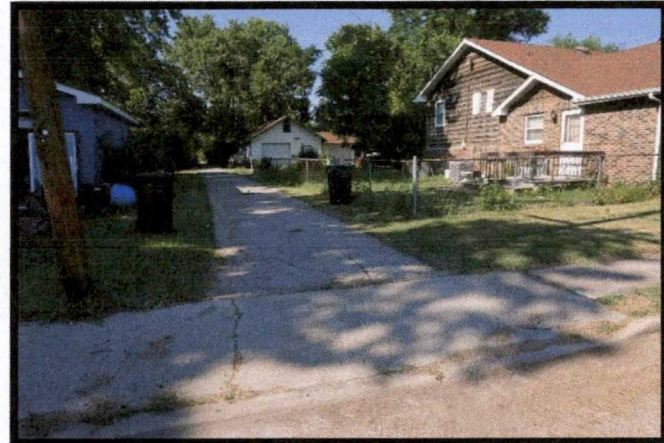
Photograph 22: EPA Alley 26 (view north from Allen Street).

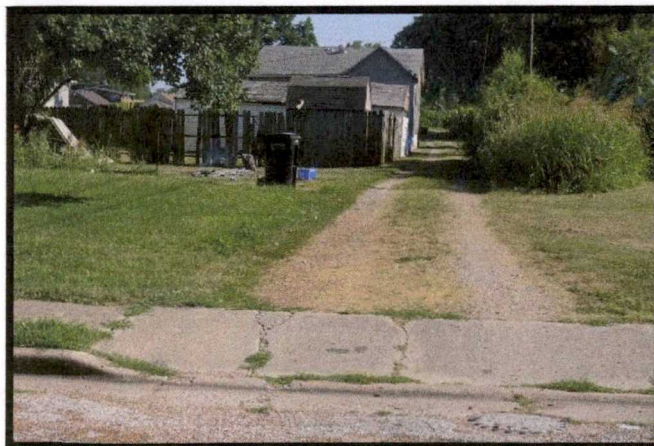
Photograph 23: EPA Alley 25, remediated by EPA (view south from Allen Street).

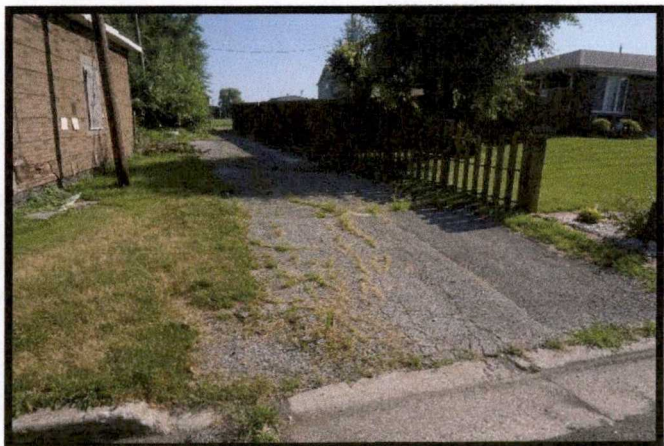
Photograph 24: EPA Alley 29 (view south from Madison Street/College Street).

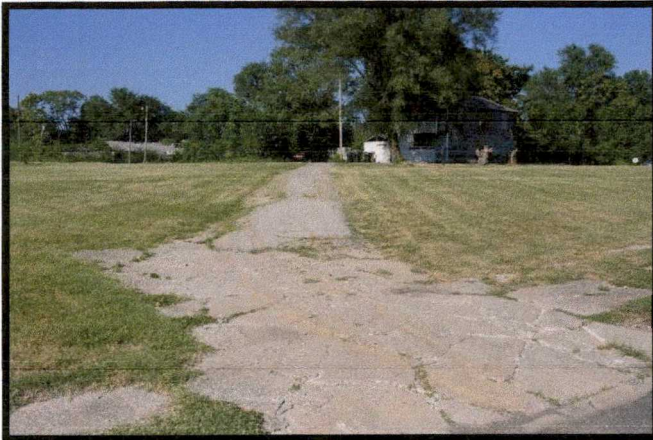
Photograph 25: EPA Alley 29 (view northeast from Jackson Street).

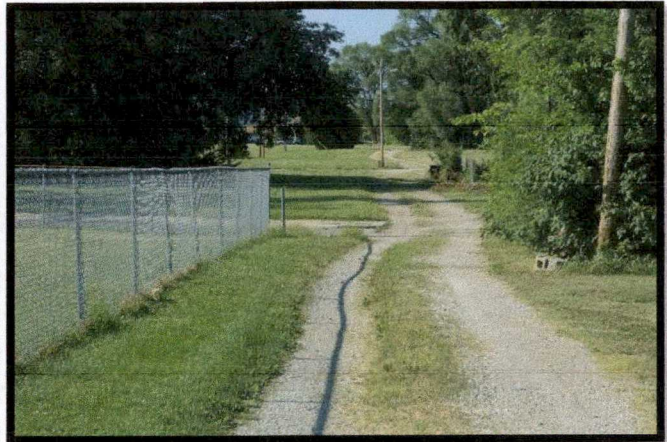
Photograph 26: EPA Alley 30, remediated by EPA (view north from Alley 30 toward Franklin Street).

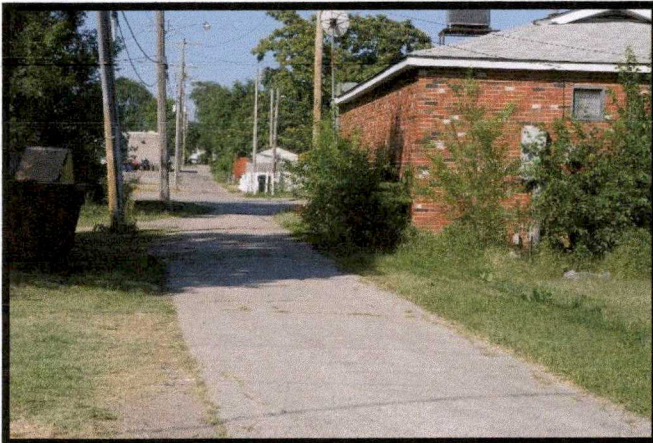
Photograph 27: EPA Alley 43 (view northeast toward 4th Street).

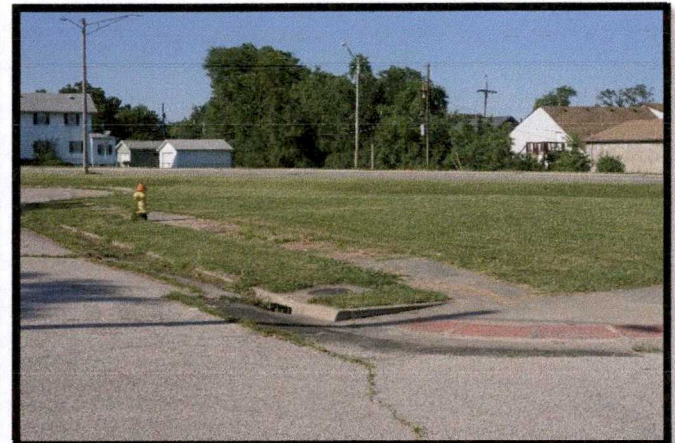
Photograph 28: EPA Alley 51, remediated by EPA and eliminated as part of redevelopment (view north from Hampden).

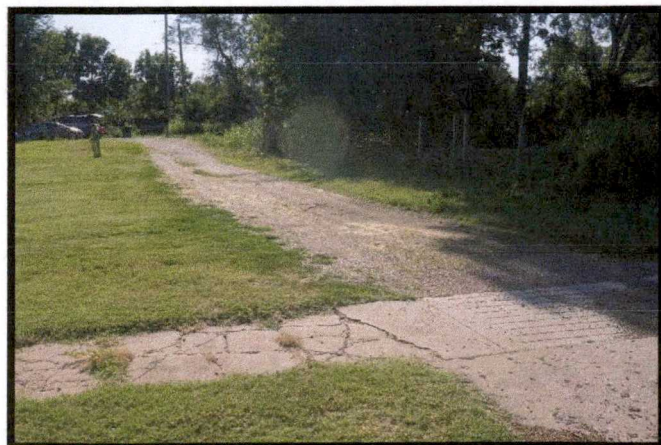
Photograph 29: EPA Alley 61, remediated by EPA (view west from 3rd Street).

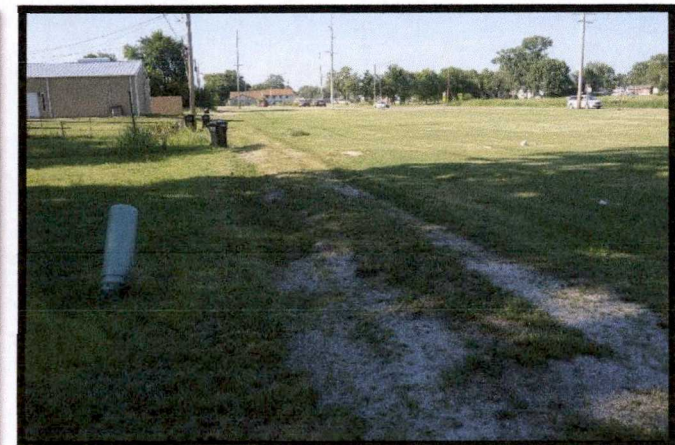
Photograph 30: EPA Alley 52 (view north from Granville).

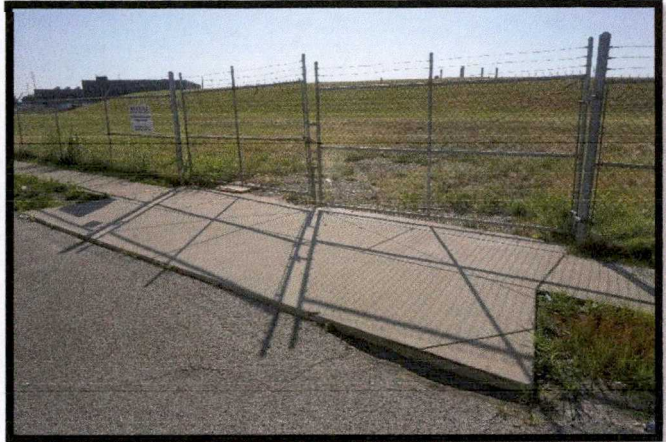
Photograph 2: Entrance to 1555 State Street property along State Street.

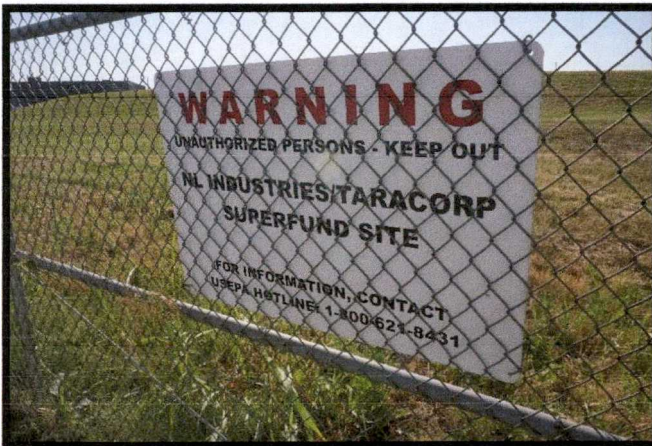
Photograph 3: Warning sign at front gate along State Street.

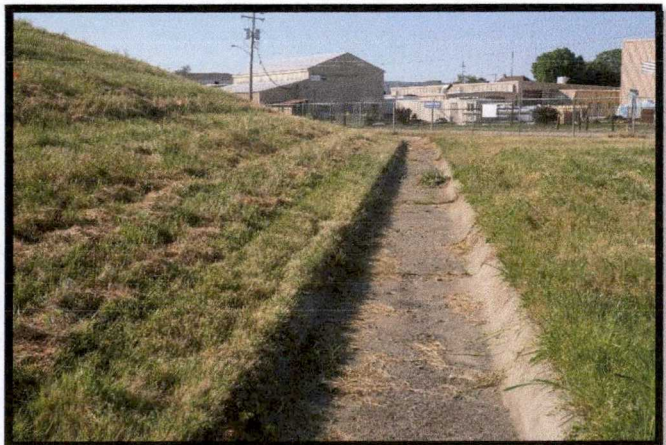
Photograph 6: Concrete drainage swale, east side of Taracorp pile (view north).

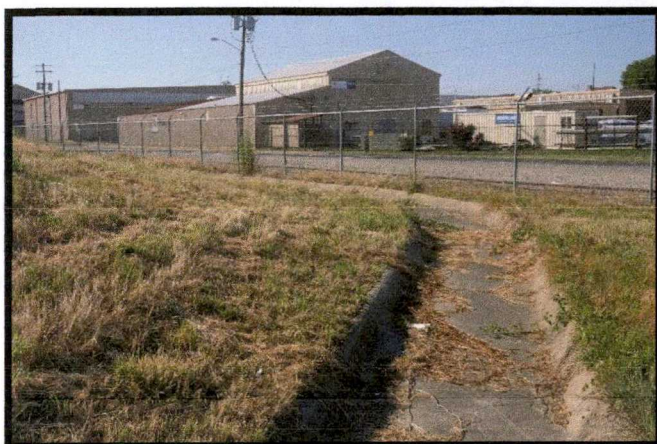
Photograph 7: Concrete drainage swale, east side of Taracorp pile (view north).

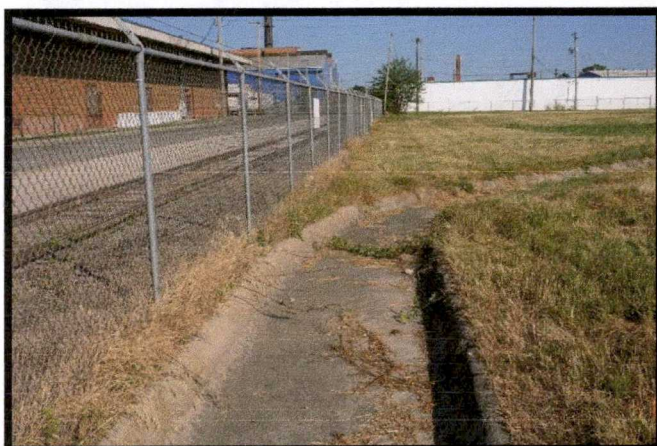
Photograph 9: Concrete drainage swale, northeast side of Taracorp pile (view southeast).

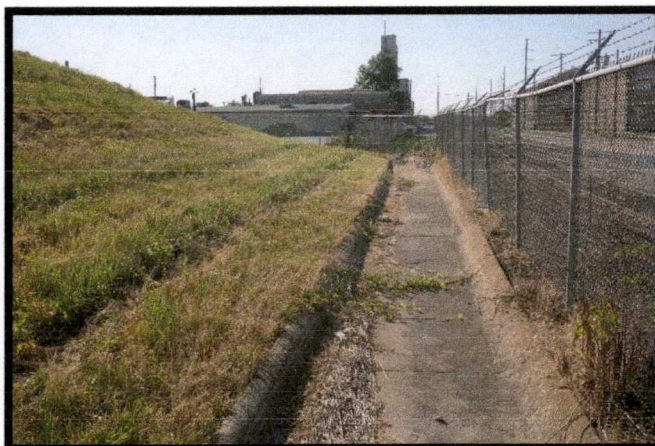
Photograph 10: Concrete drainage swale, fence, and vegetation; northeast side of Taracorp pile along 16th Street (view northwest).

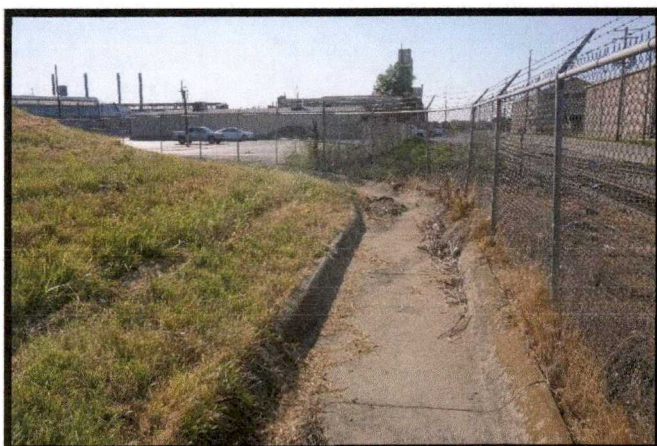
Photograph 11: Concrete drainage swale, fence, and vegetation; north side of Taracorp pile along 16th Street (view northwest).

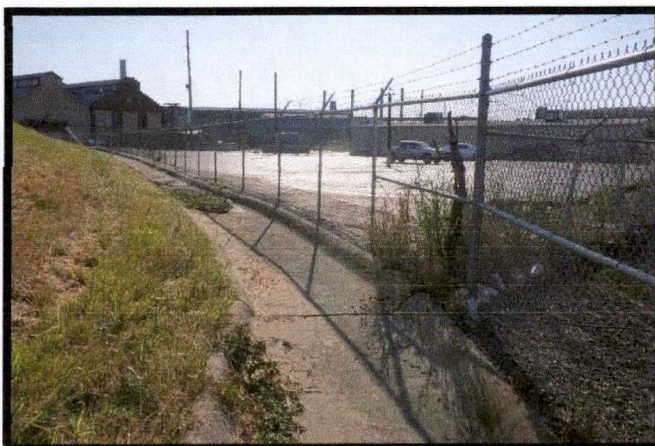
Photograph 12: Concrete drainage swale, fence, and vegetation; north side of Taracorp pile along 16th Street (view west).

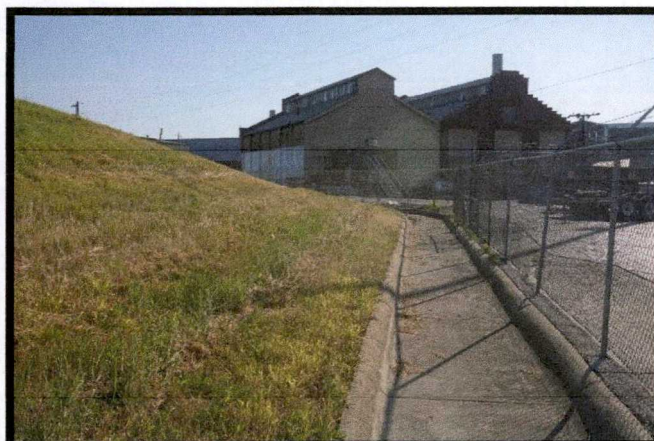
Photograph 14: Vegetation, northwestern side of Taracorp pile cap (view southwest).

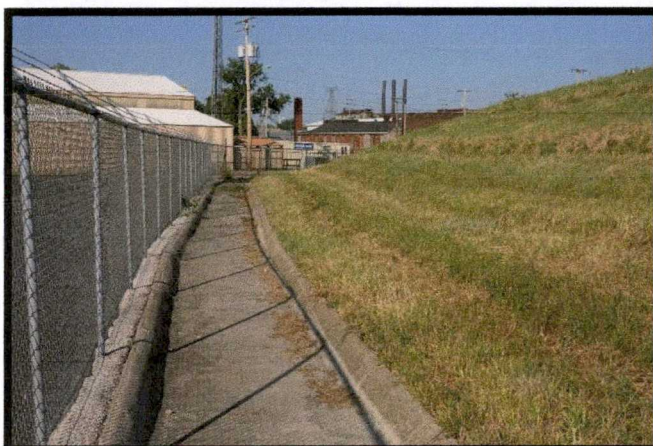
Photograph 15: Concrete drainage swale, fence, and vegetation along northwestern side of Taracorp pile (view northeast).

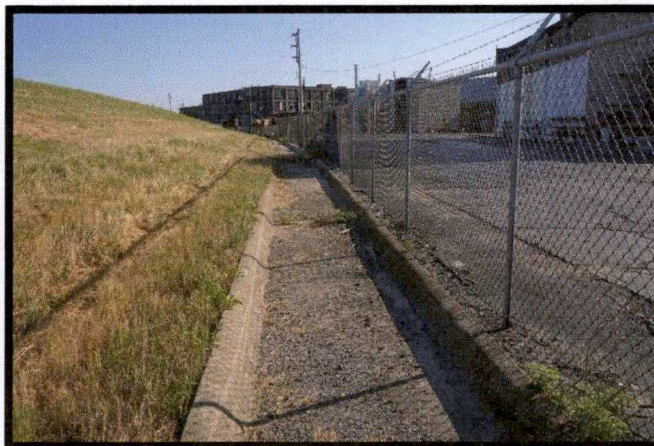
Photograph 18: Concrete drainage swale and vegetation along northwestern side of Taracorp pile (view southwest).

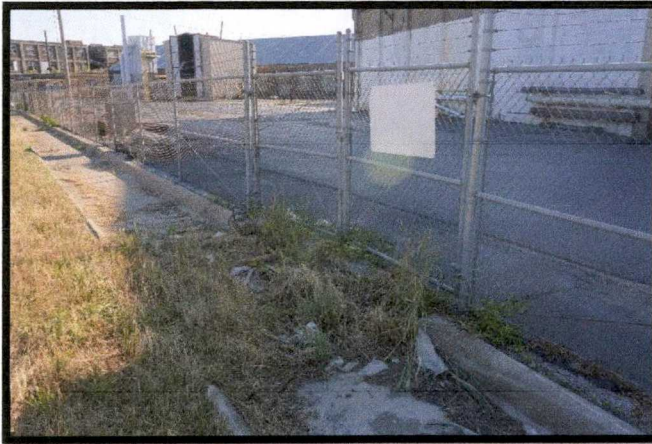
Photograph 19: Fence (gate), warning sign, concrete drainage swale, vegetation along northwestern side of Taracorp pile (view west).

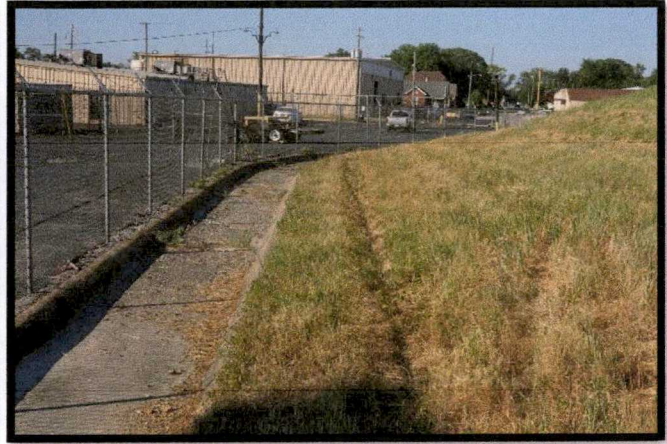
Photograph 20: Concrete drainage swale, vegetation along western side of Taracorp pile (view north/north-east).

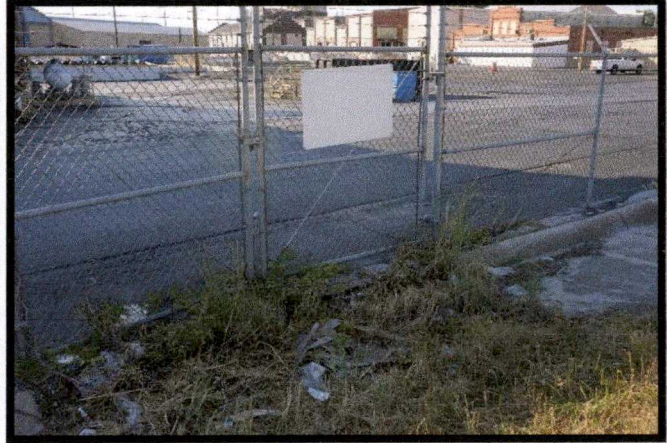
Photograph 22: Fence (gate), warning sign along western side of Taracorp pile (view west).

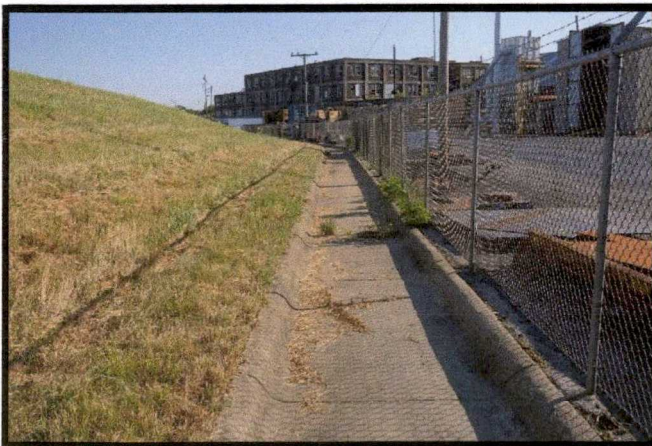
Photograph 23: Concrete drainage swale, fence, and vegetation near base of western side of Taracorp pile (view southwest).

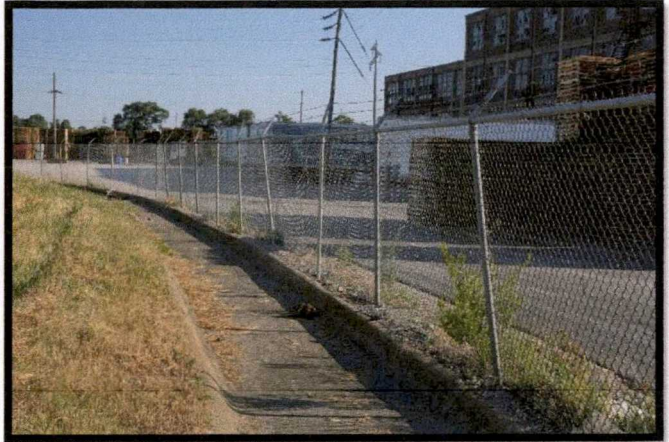
Photograph 26: Concrete drainage swale, fence, and vegetation near base of western side of Taracorp pile (view southwest).

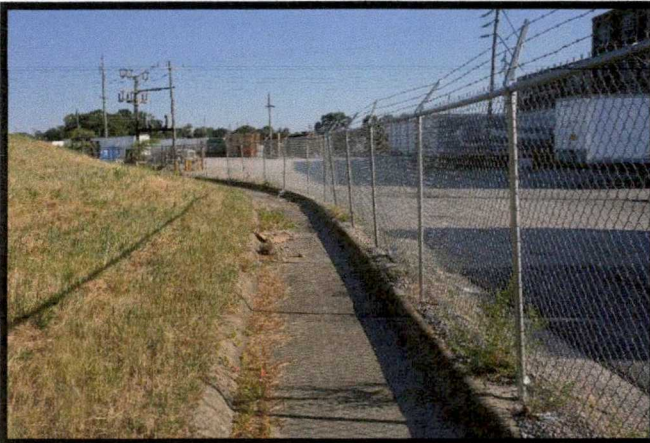
Photograph 27: Concrete drainage swale, fence, and vegetation near base of western side of Taracorp pile (view southwest).

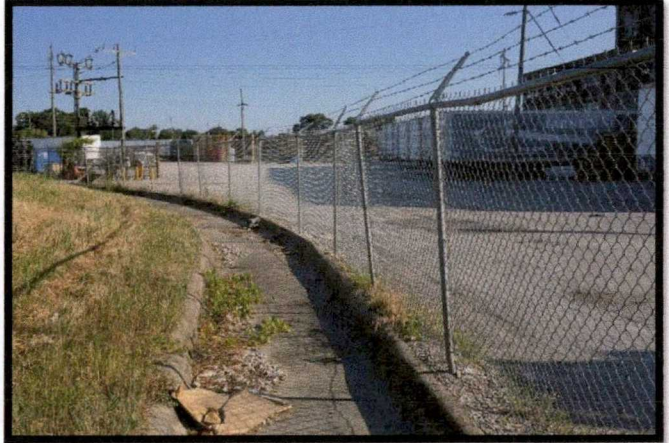
Photograph 28: Concrete drainage swale, fence, western side of Taracorp pile (view southwest).

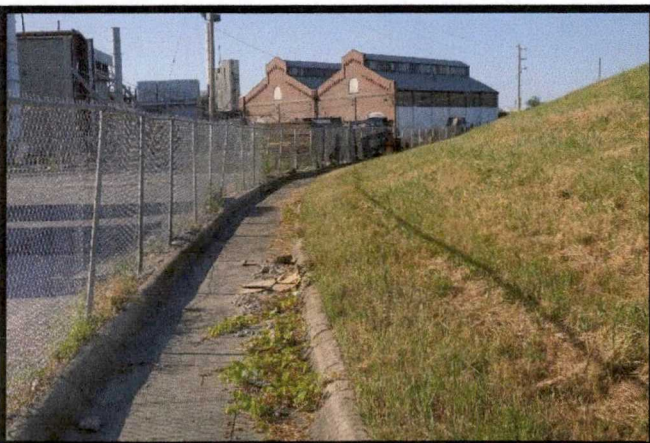
Photograph 29: Concrete drainage swale, fence, western side of Taracorp pile (view north).

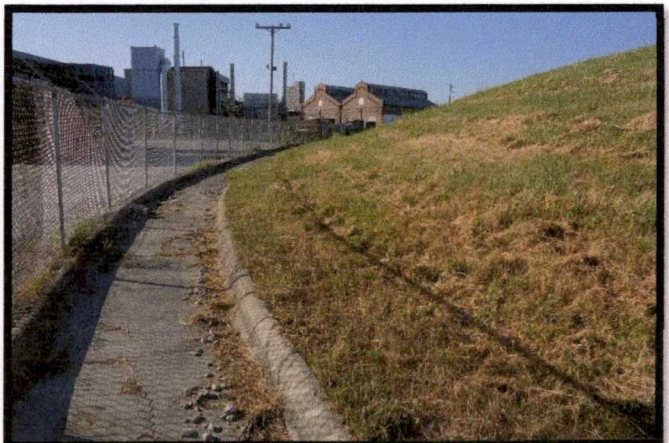
Photograph 30: Concrete drainage swale, fence, western side of Taracorp pile (view north).

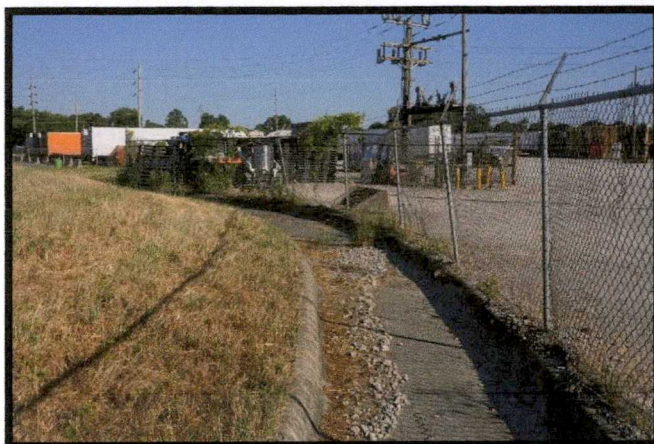
Photograph 31: Concrete drainage swale, fence, western side of Taracorp pile (view south).

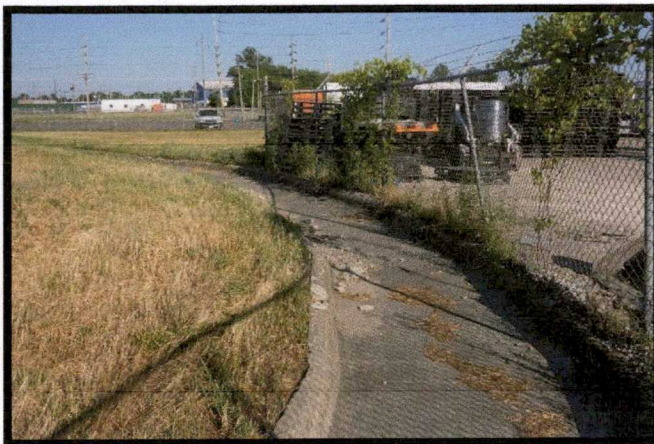
Photograph 32: Concrete drainage swale, fence, western side of Taracorp pile (view south).

- The Group's lawn maintenance contractor, Munie Greencare Professionals (Munie), cut the vegetation on the Taracorp pile cap and the 1555 State Street property on June 21, 2022. Based on the results of the inspection, the Group's project coordinator requested that Munie apply herbicide to control the growth of vegetation on the fence in several areas on the 1555 State Street and Taracorp pile properties (Attachment 5, photographs 32, 38, 51, 66, and 67).

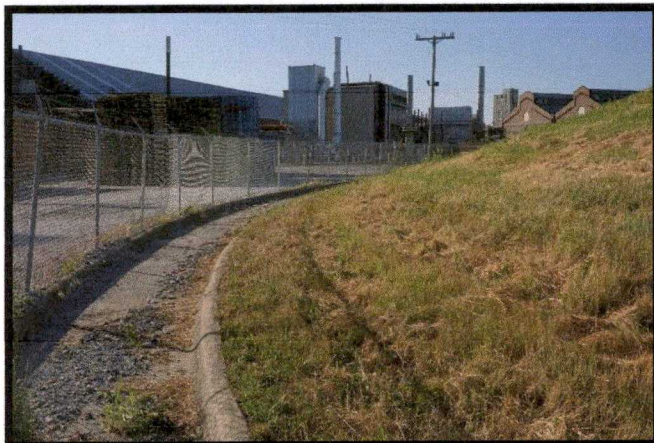
Photograph 33: Concrete drainage swale, fence, western side of Taracorp pile (view north).

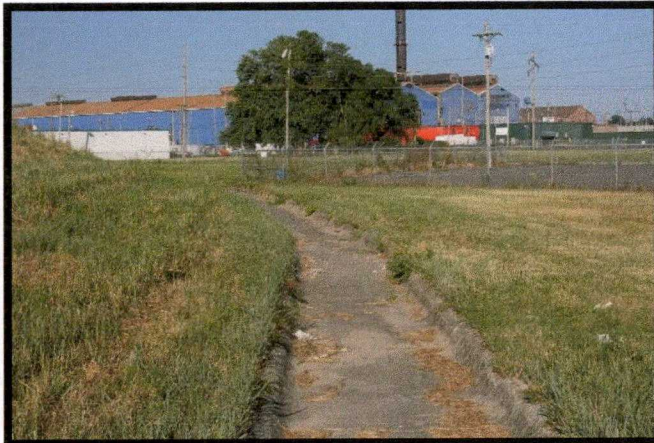
Photograph 34: Concrete drainage swale, fence, western side of Taracorp pile (view east).

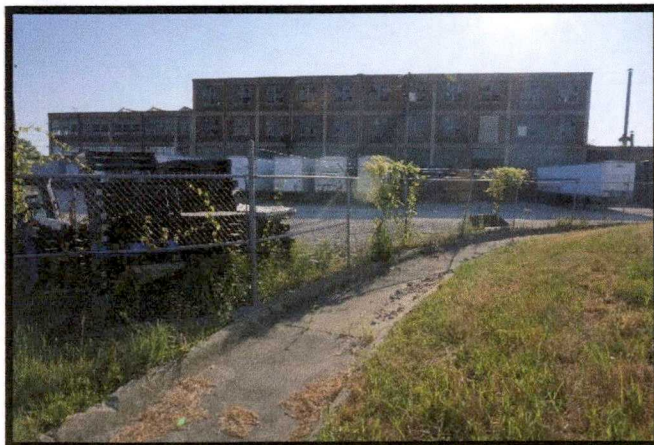
Photograph 35: Concrete drainage swale, fence, and vegetation near base of southern side of Taracorp pile (view west).

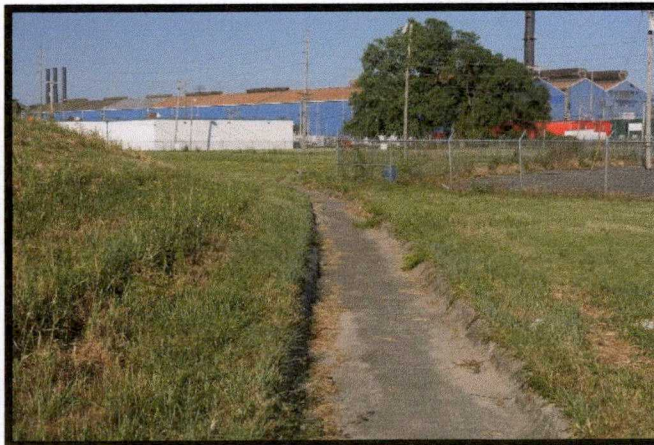
Photograph 36: Concrete drainage swale, fence, southern side of Taracorp pile (view east).

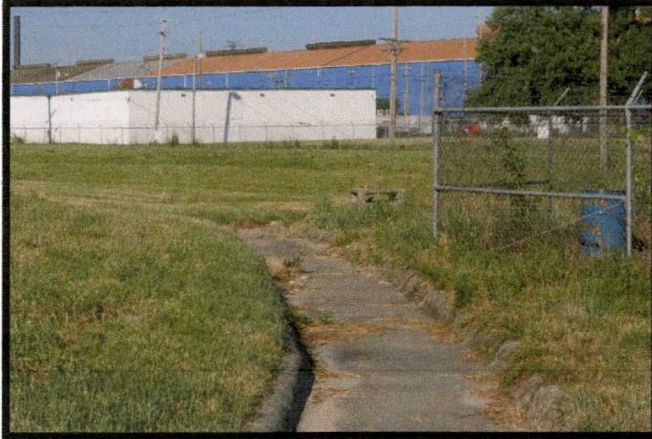
Photograph 37: Concrete drainage swale, fence, and vegetation near base of southern side of Taracorp pile cap (view east).

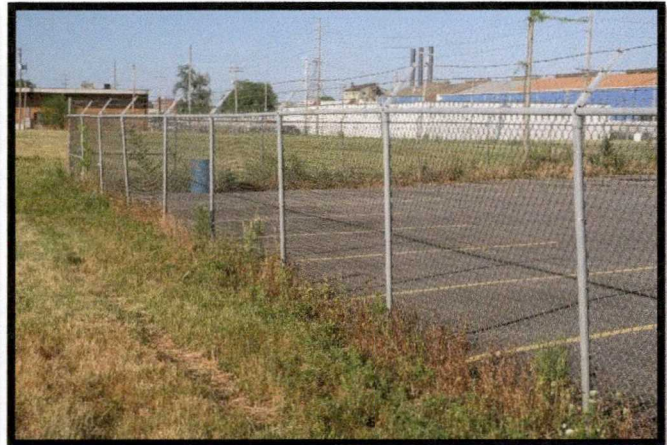
Photograph 40: Fence along southern side of Taracorp pile.

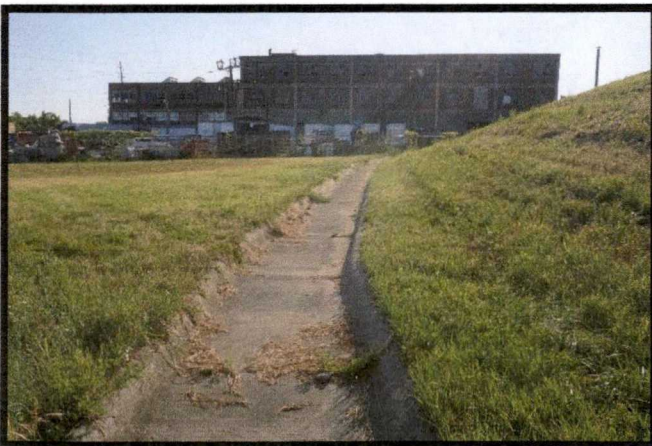
Photograph 41: Concrete drainage swale, southwestern side of Taracorp pile cap (view west).
